**CONSENT ORDER
ISSUED UNDER THE
WATER POLLUTION CONTROL ACT
WEST VIRGINIA CODE, CHAPTER 22, ARTICLE 11**

TO: Mountain Valley Pipeline, LLC
Attn: Robert J. Cooper
Senior Vice President, Engineering and Construction
625 Liberty Ave, Ste 1700
Pittsburgh, PA 15222

DATE: April 19, 2019

ORDER NO.: 8951

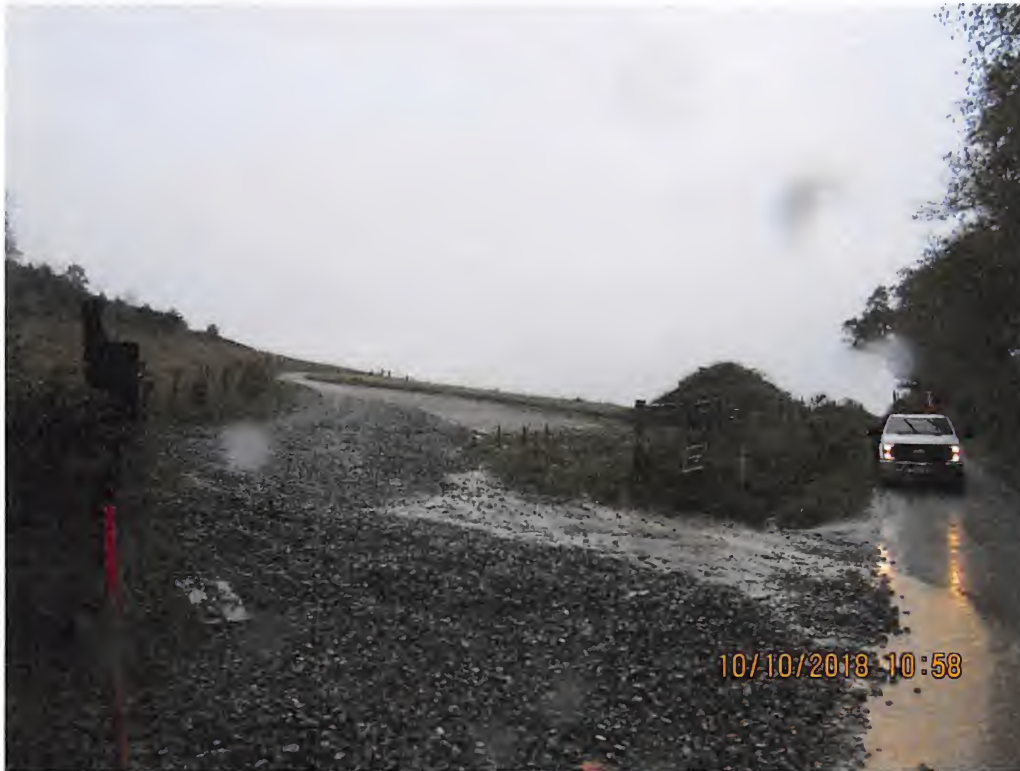
Photo 1: AR 210- sediment laden water leaving site.

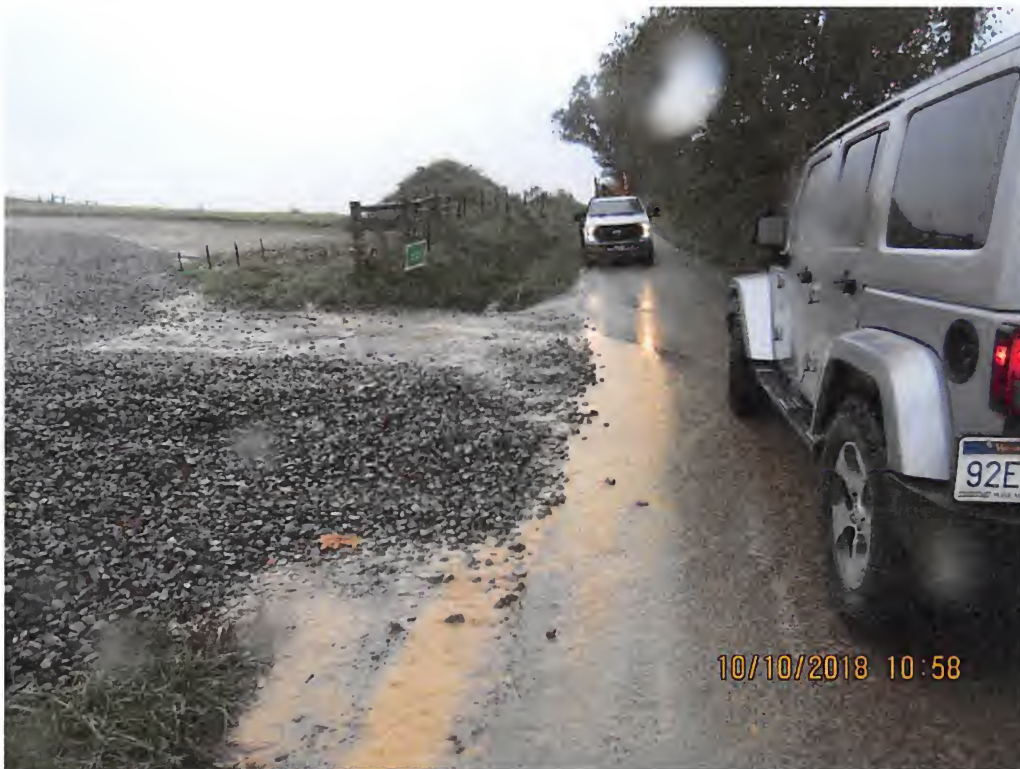
Photo 2: AR 210-sediment laden water leaving site entering county road- up gradient view.

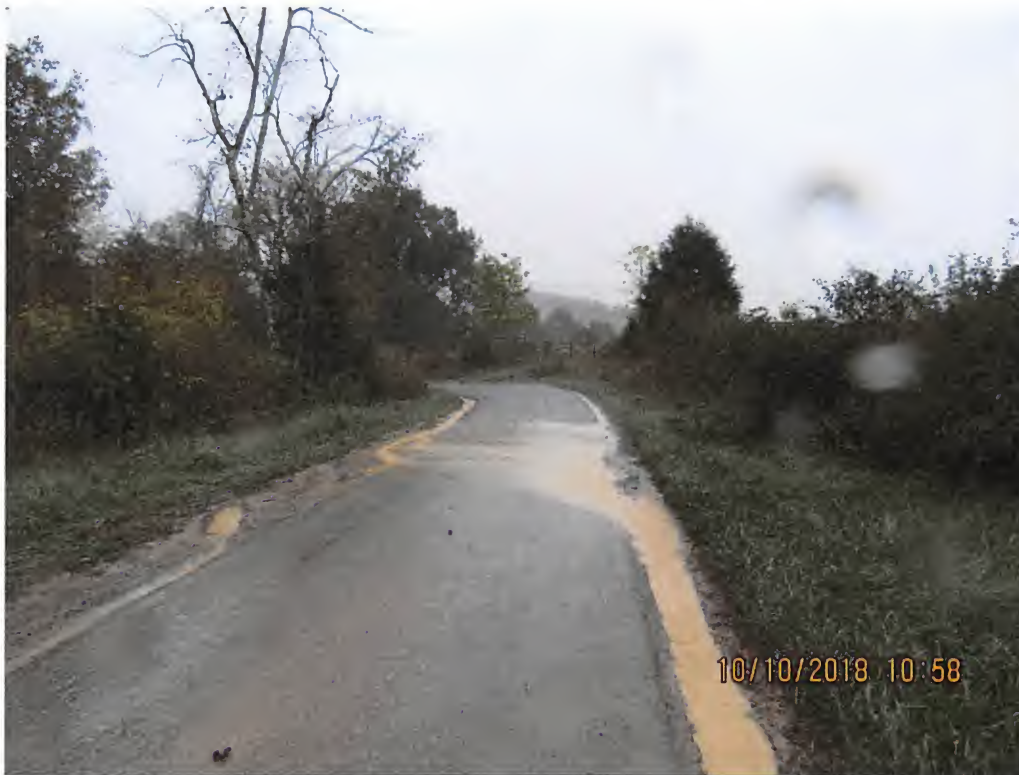
Photo 3: AR 210 sediment laden water crossing county road- down gradient view.

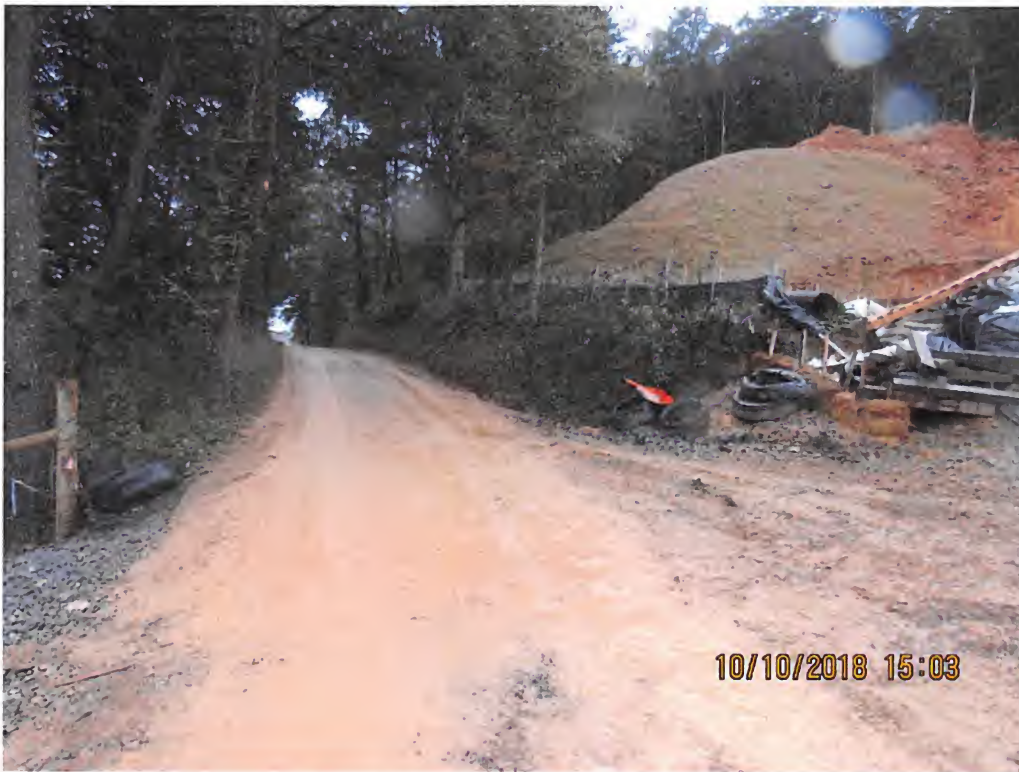
Photo 4: Painter's Run Road station 10270 at access road crossing.

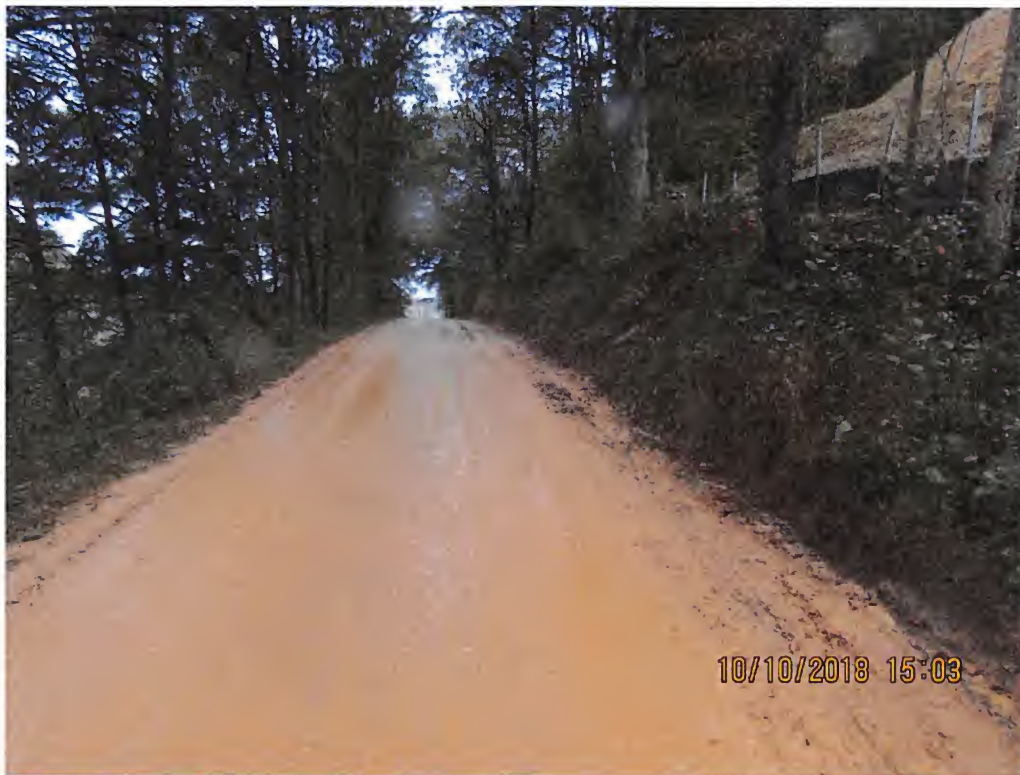
Photo 5: Painter's Run Road station 10270 upgradient of access road crossing.

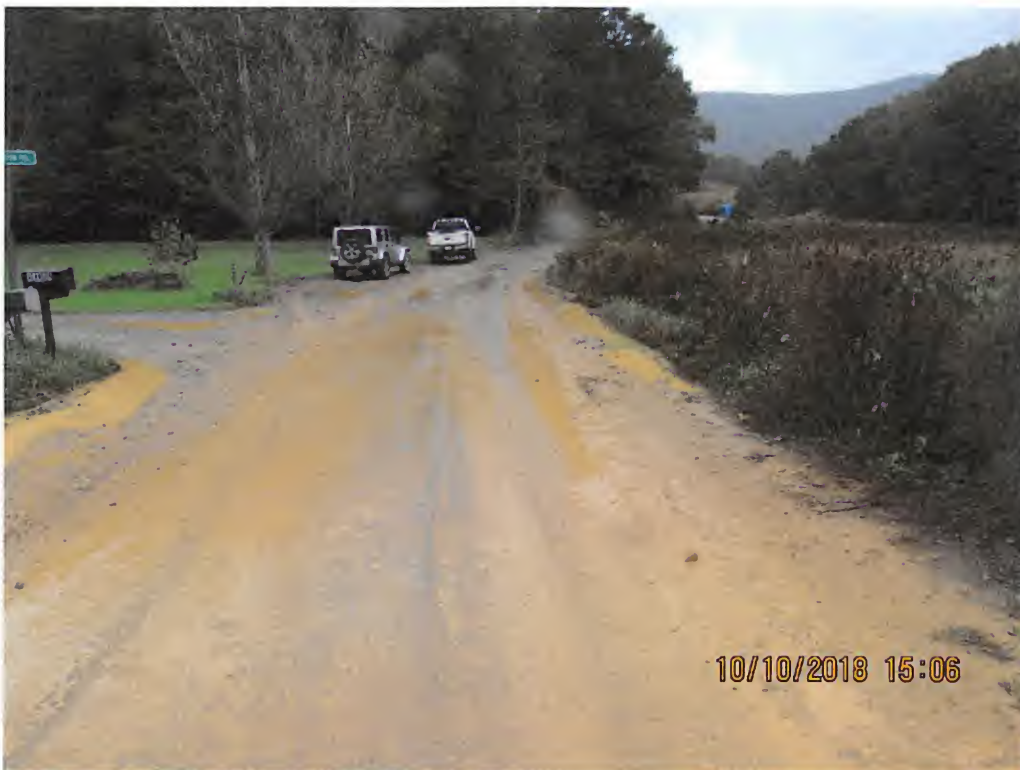
Photo 6: Painter's Run Road station 10270 down gradient of access road crossing.

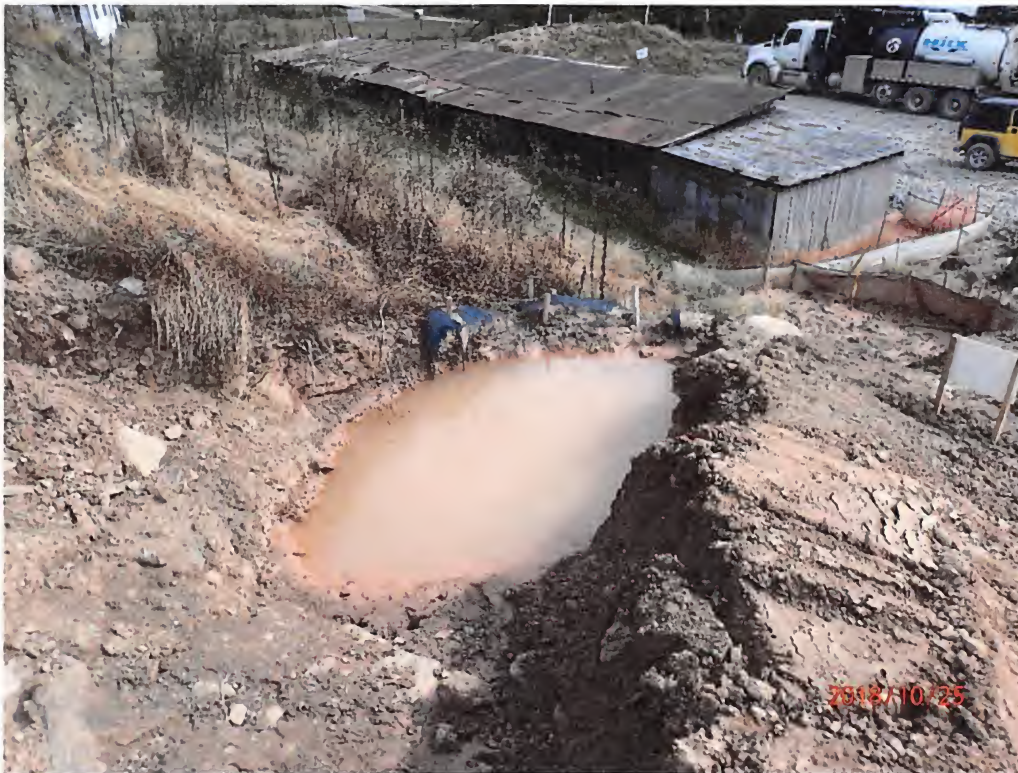
Overwhelmed sump near Sams Run.

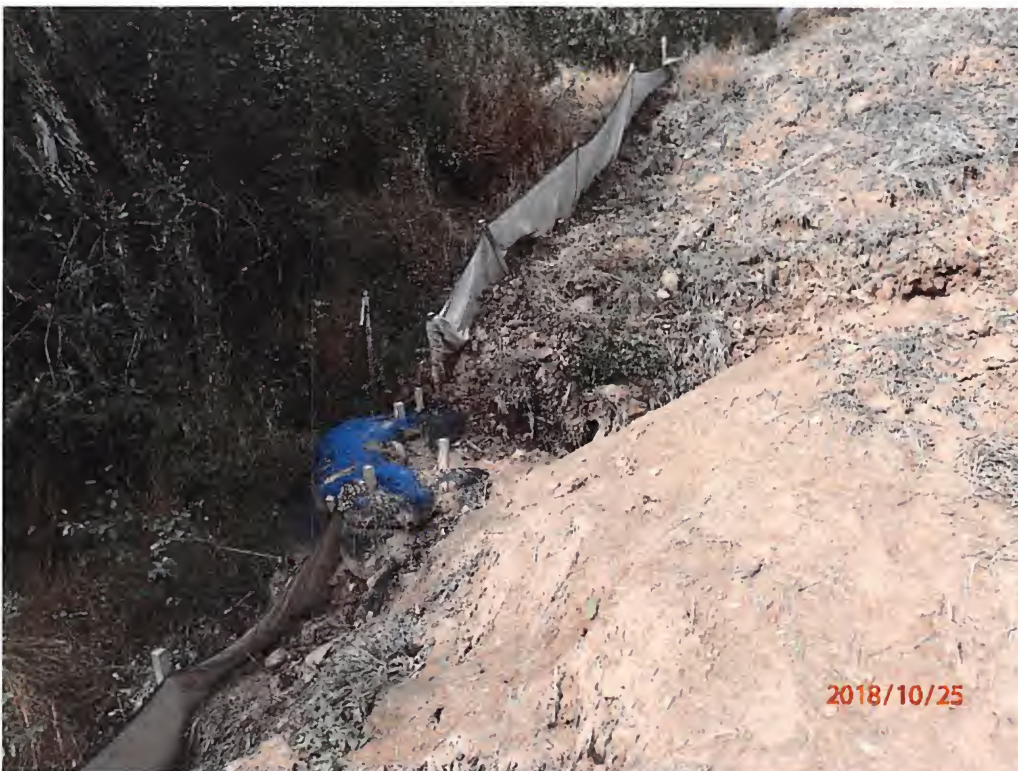
Overwhelmed sump near Sams Run.

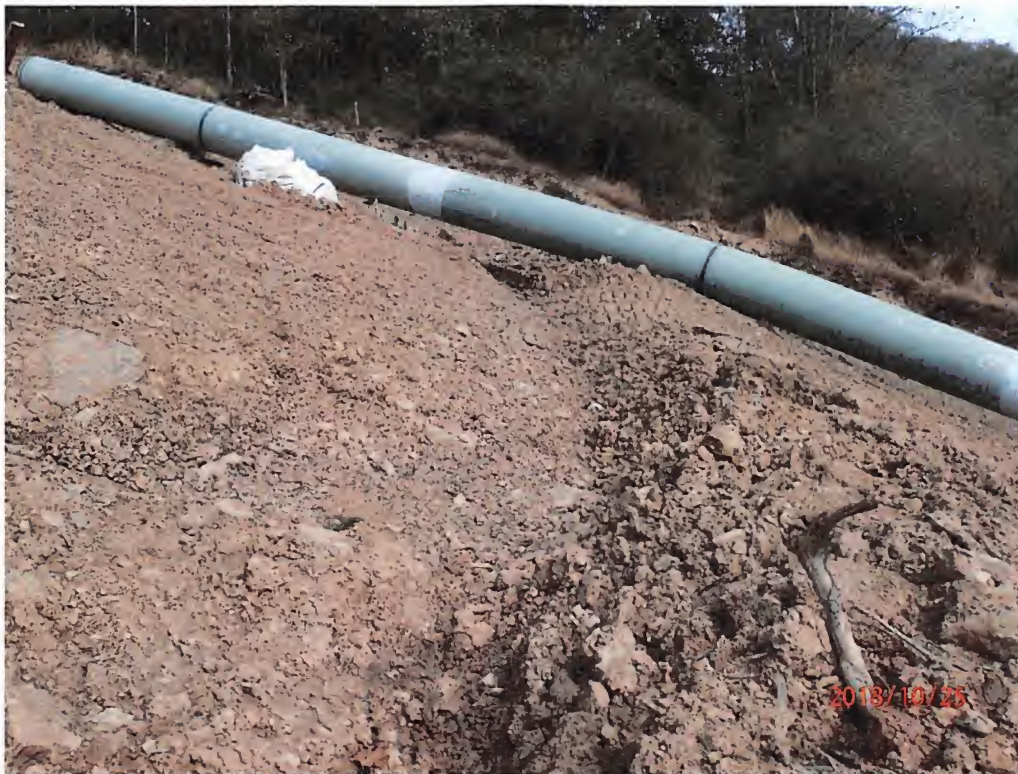
Damaged waterbar directly N of Sams Run.

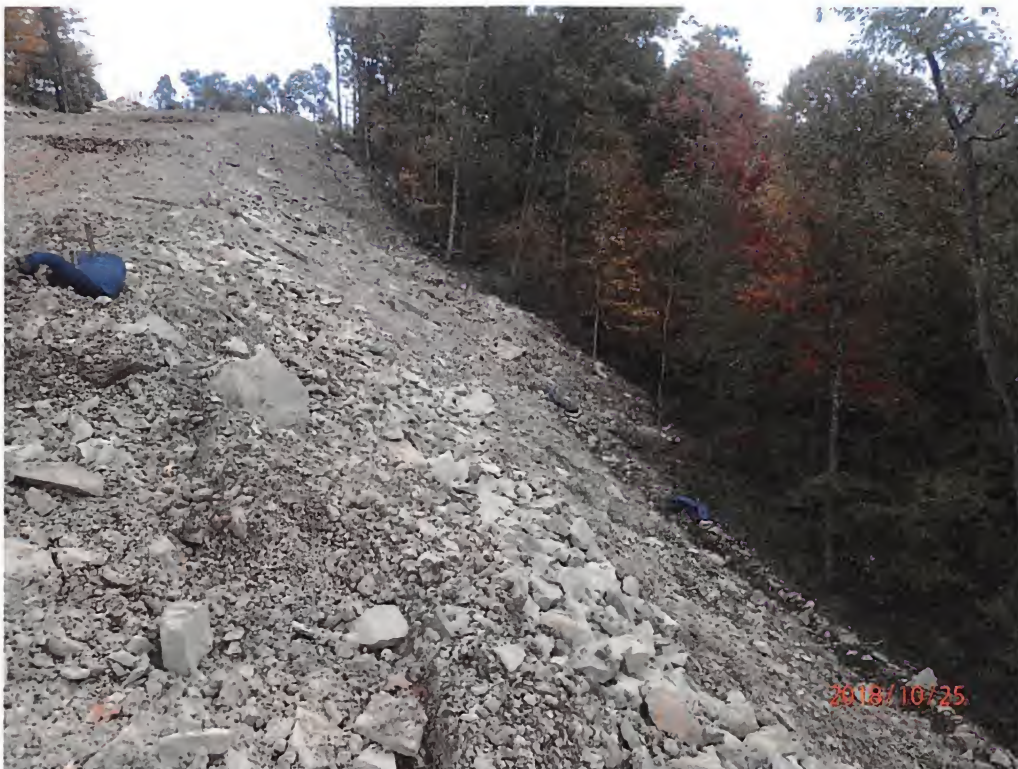
Slip at Station 489 entered the ditchline from a sideslope allowing sediment to leave the project ROW.

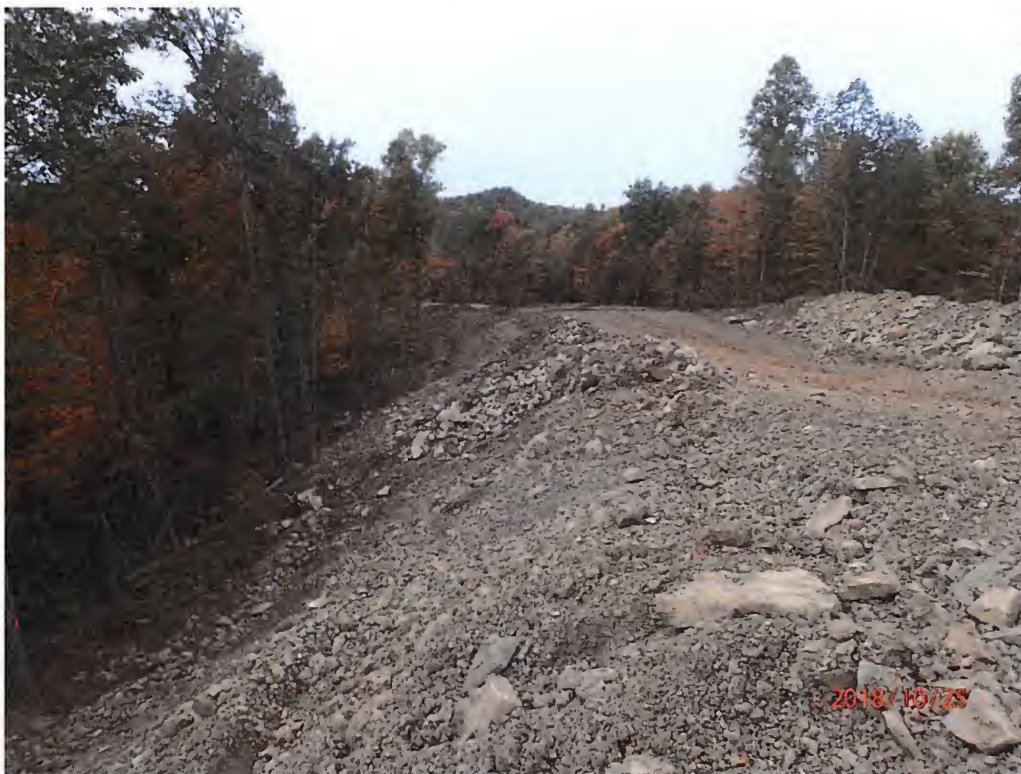
Slip at station 493 had entered the ditchline from a sideslope allowing sediment to leave the project ROW.

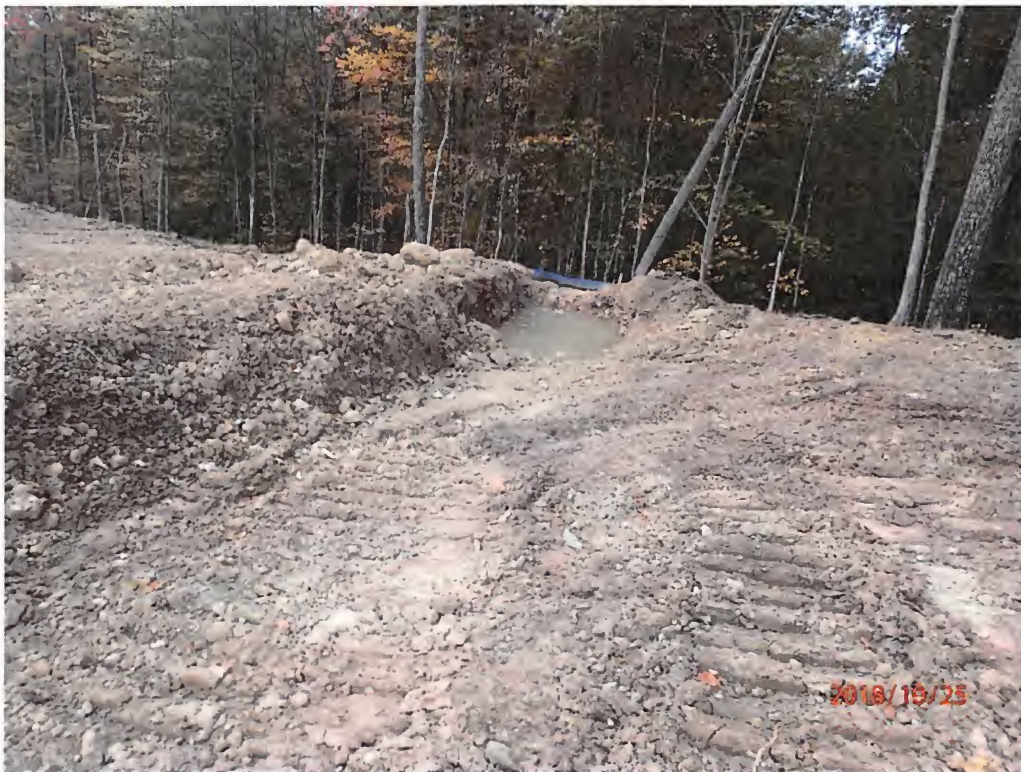
Sump at Station 286 in need of maintenance.

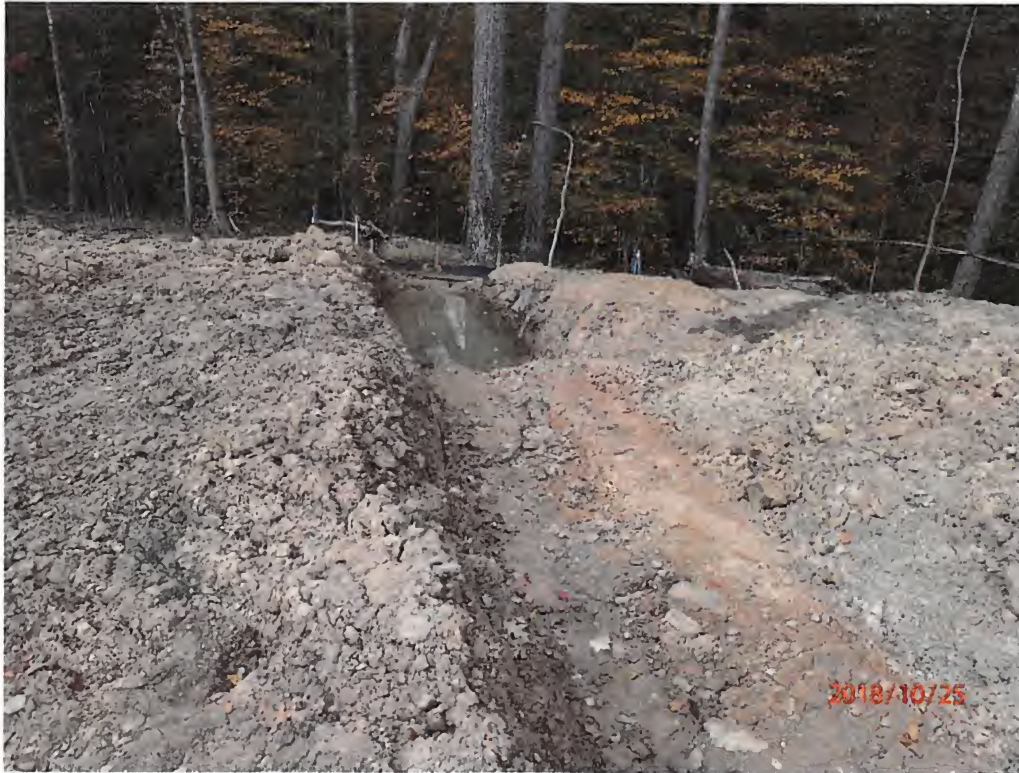
Sump at Station 290 in need of maintenance.

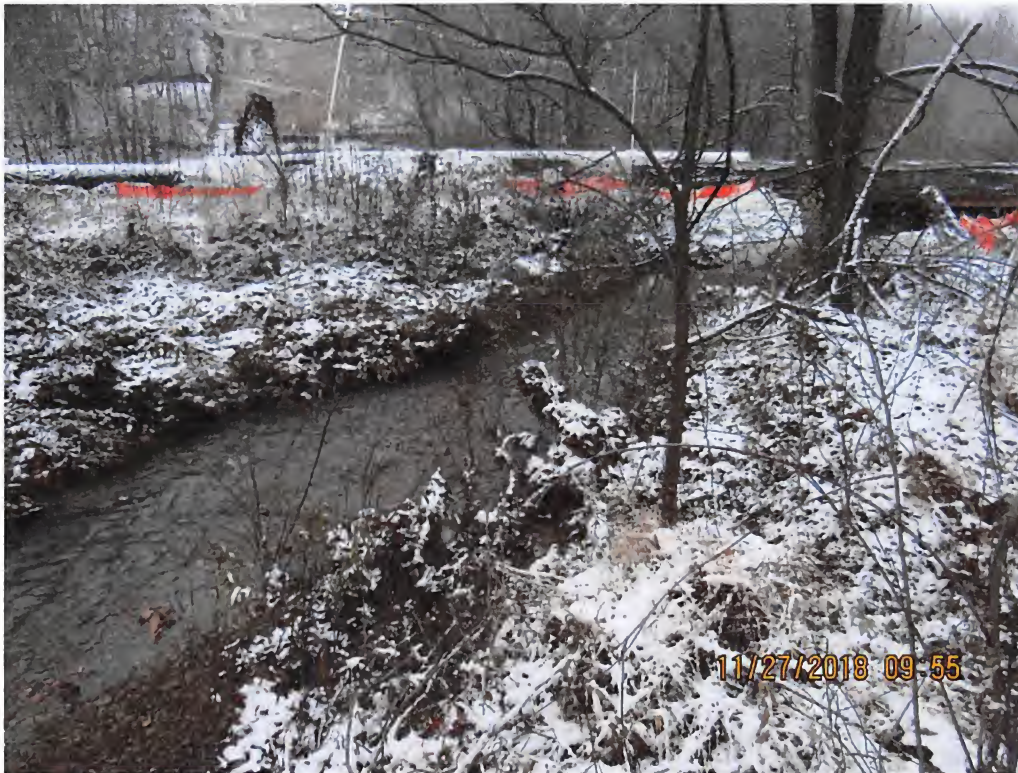
Downstream view of Knawl's Creek at location of convergence of UNT.

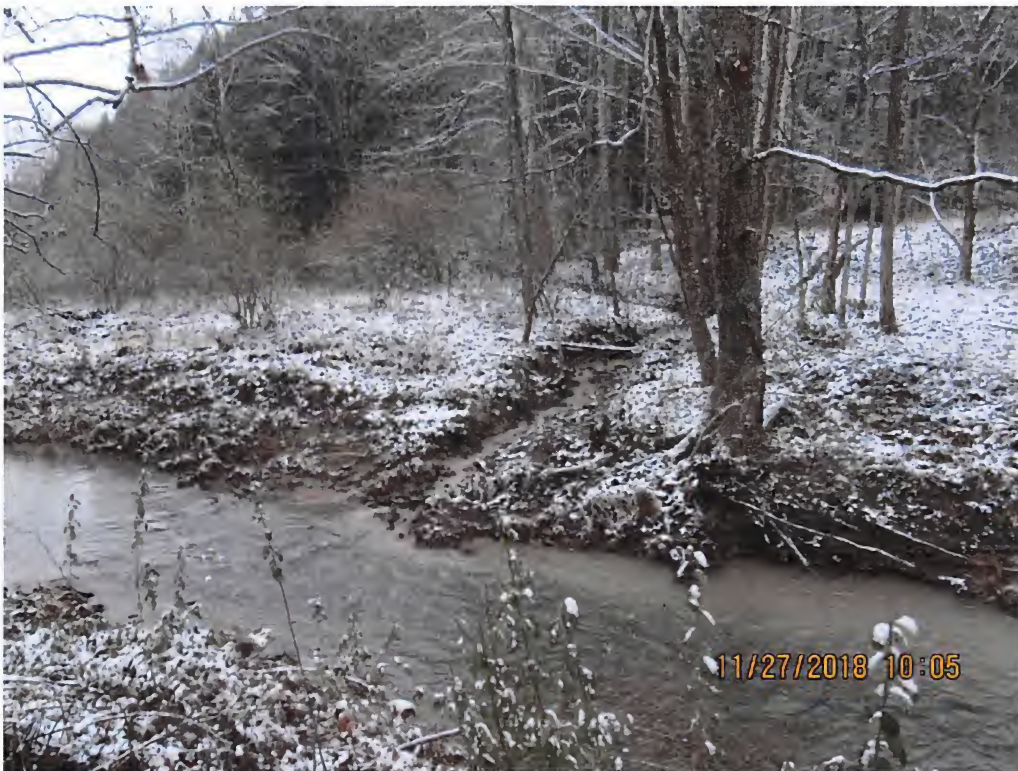
Convergence of UNT of Knawl's Creek into Knawl's Creek below release point

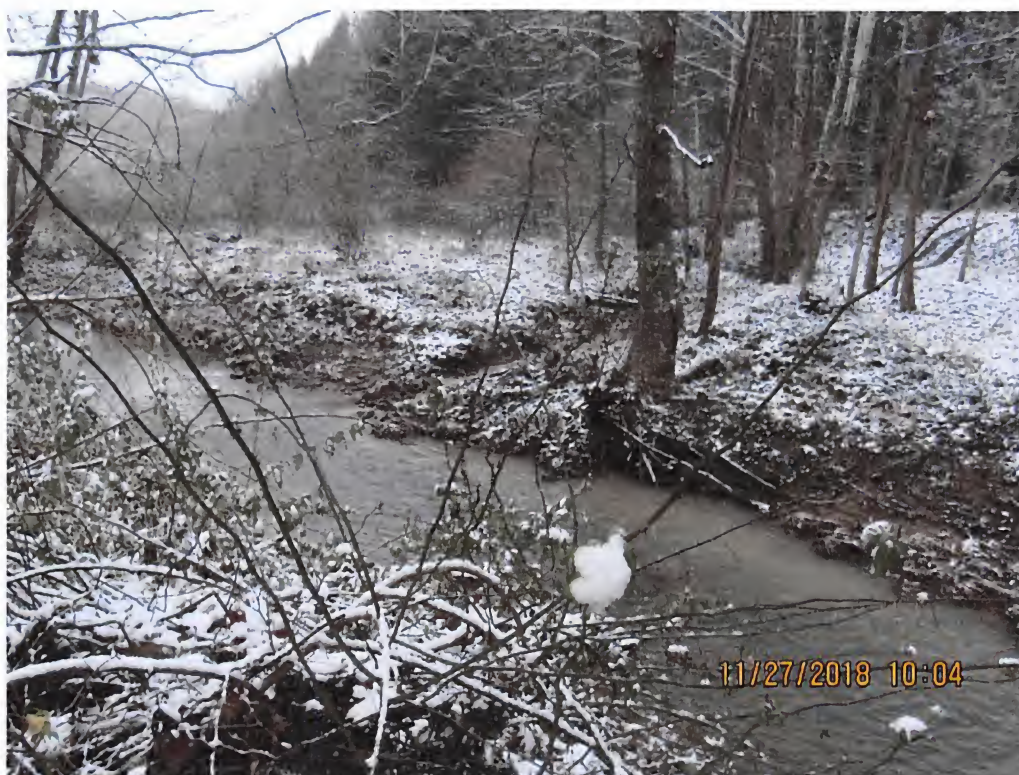
Slightly downstream of convergence point into Knawl's Creek below release point.

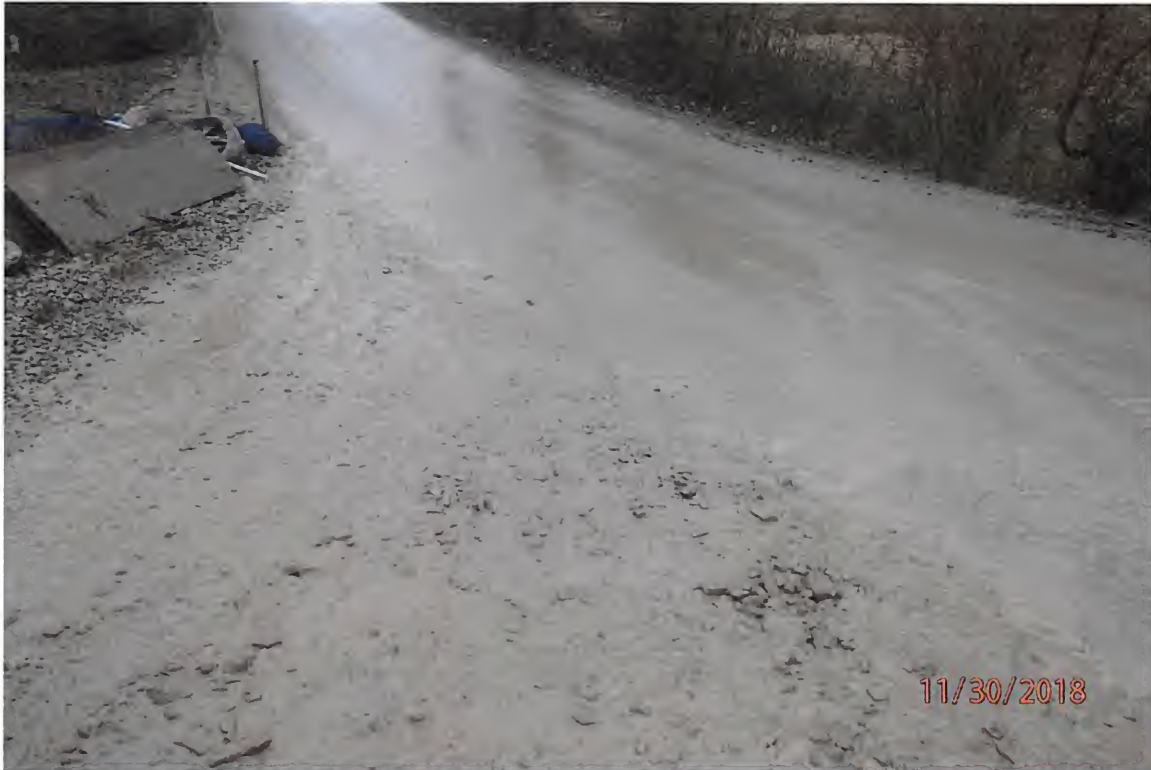
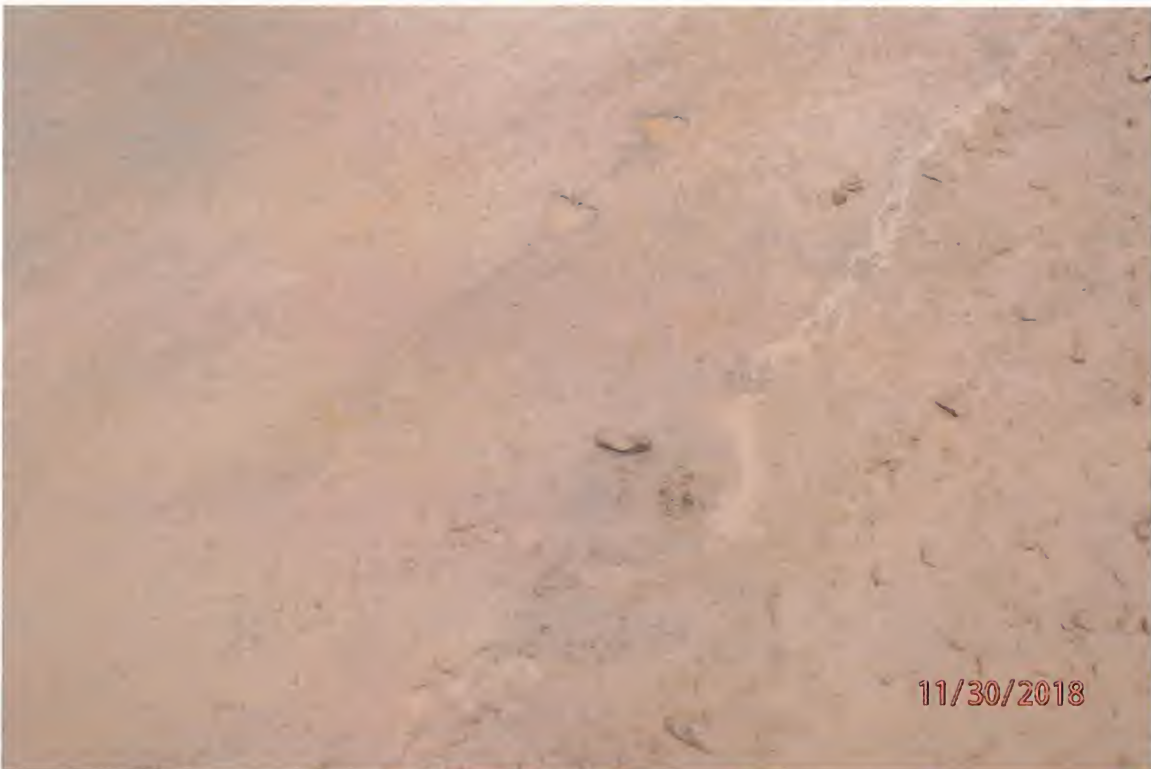
Access Road WV-HA – 31.1 off CR 50/4 showing the lack of an adequately stable construction entrance and the associated track out onto the public road.

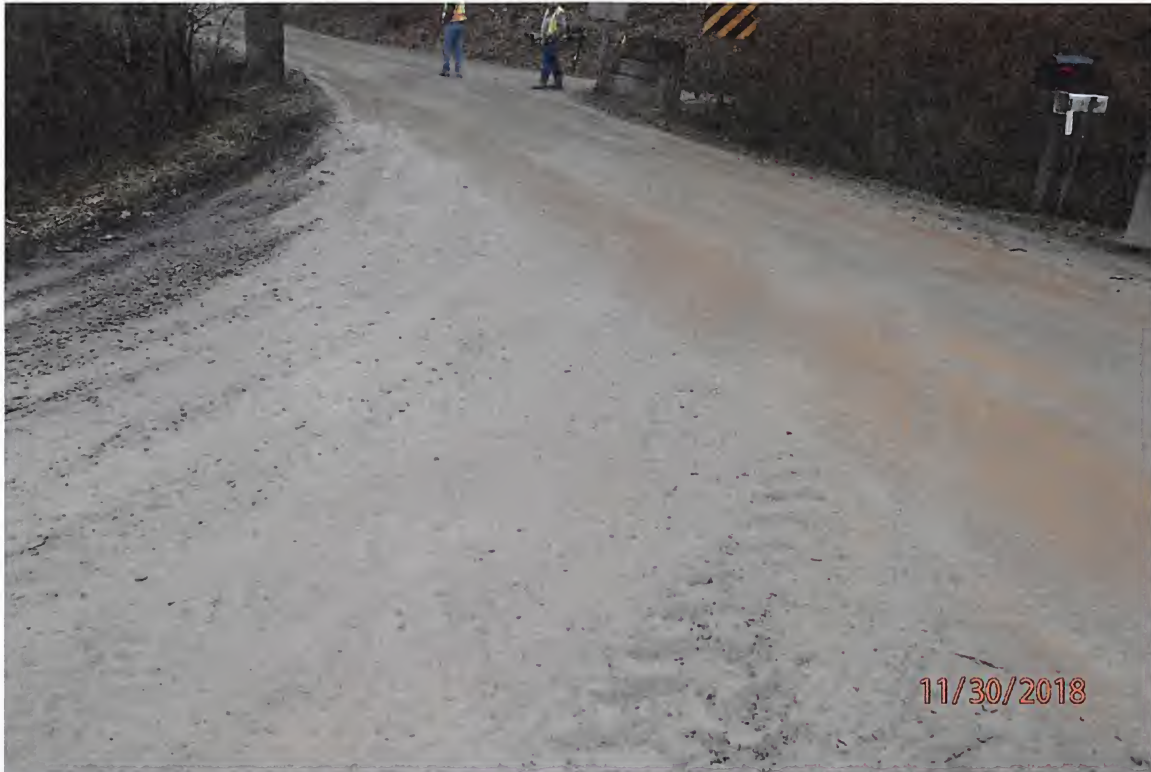
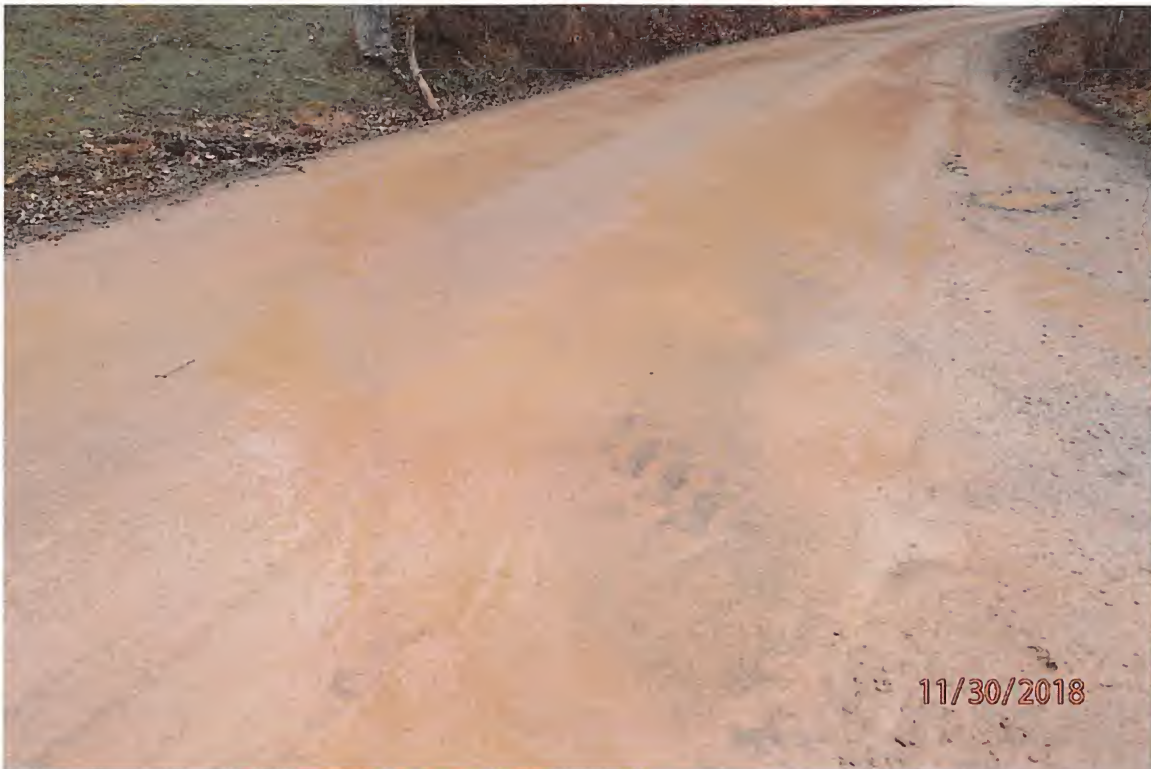
Access Road WV-HA - 29.04 off CR 50/5 showing the lack of an adequately stable construction entrance and the associated track out onto the public road.

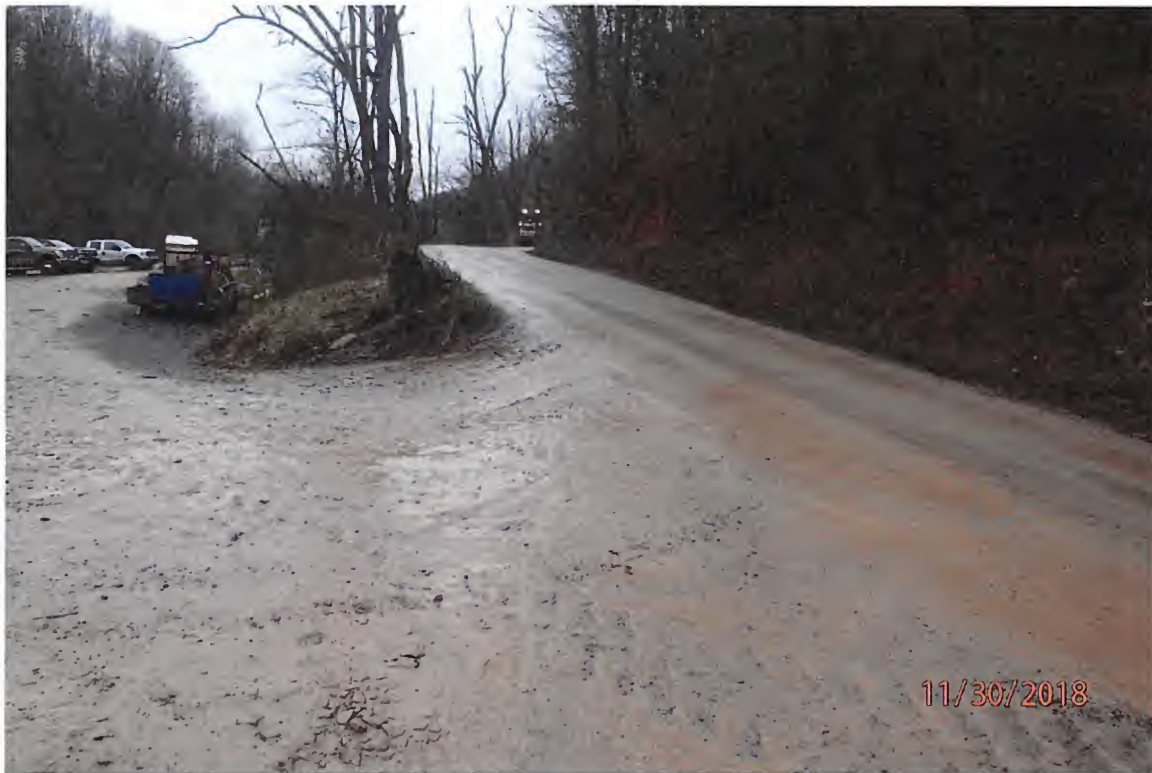
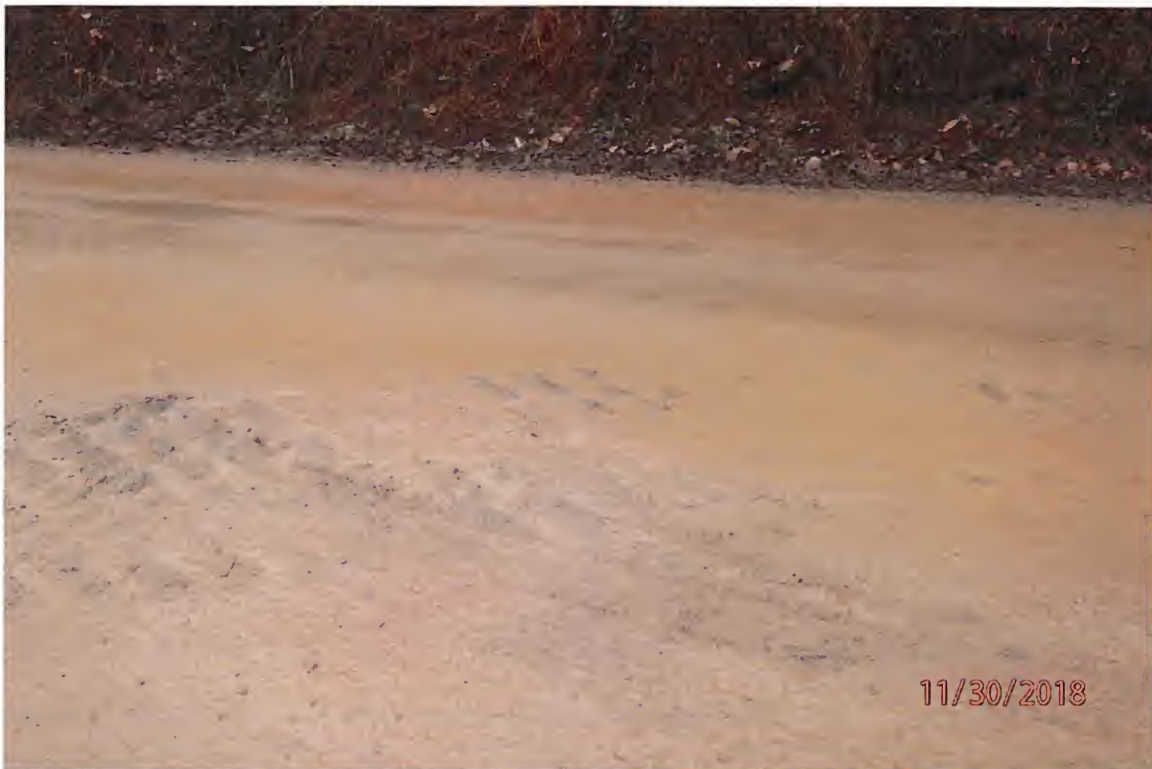
Access Road WV-HA - 29.5 off CR 50/5 showing the lack of an adequately stable construction entrance and the associated track out onto the public road.
